MERRIMACK RIVER BASIN
NEW DURHAM, NEW HAMPSHIRE

NEW DURHAM DAM
NH - 00345

PHASE I INSPECTION REPORT
NATIONAL DAM INSPECTION PROGRAM

MARCH 1979

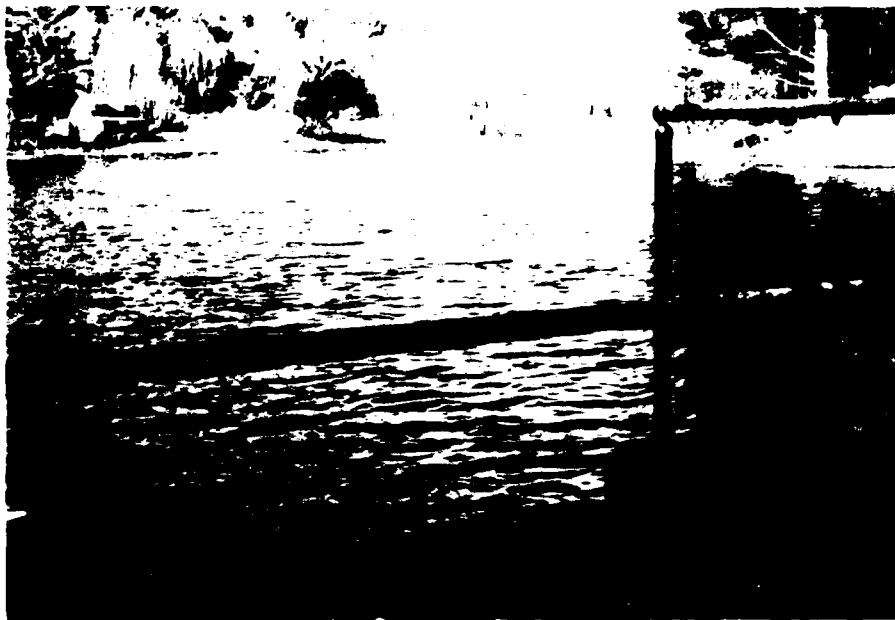
10

VIEW UPSTREAM FROM GATEHOUSE

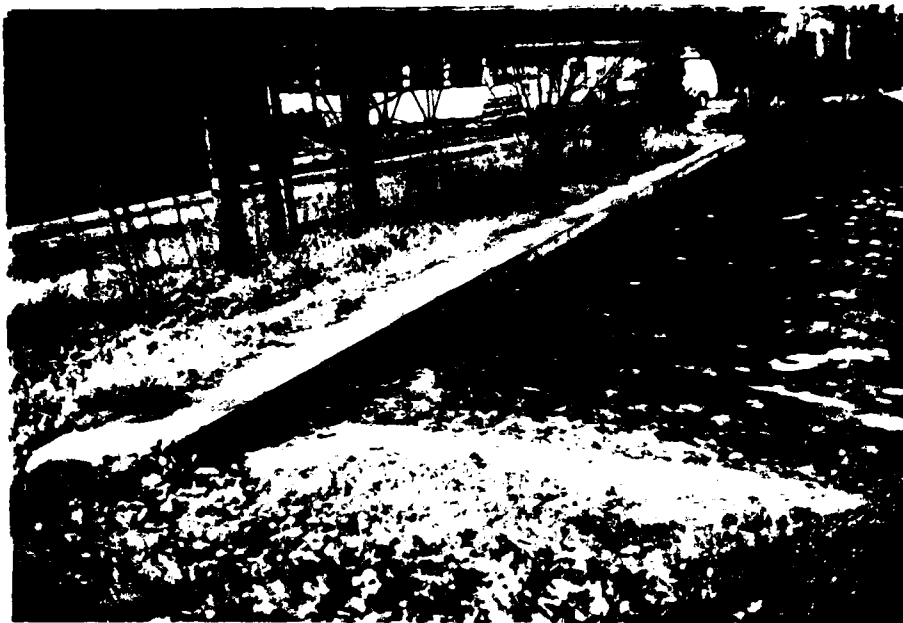
11

DIKE WITH CONCRETE WALL AT ROADSIDE
ABOUT 200 FEET WEST OF NEW DURHAM DAM

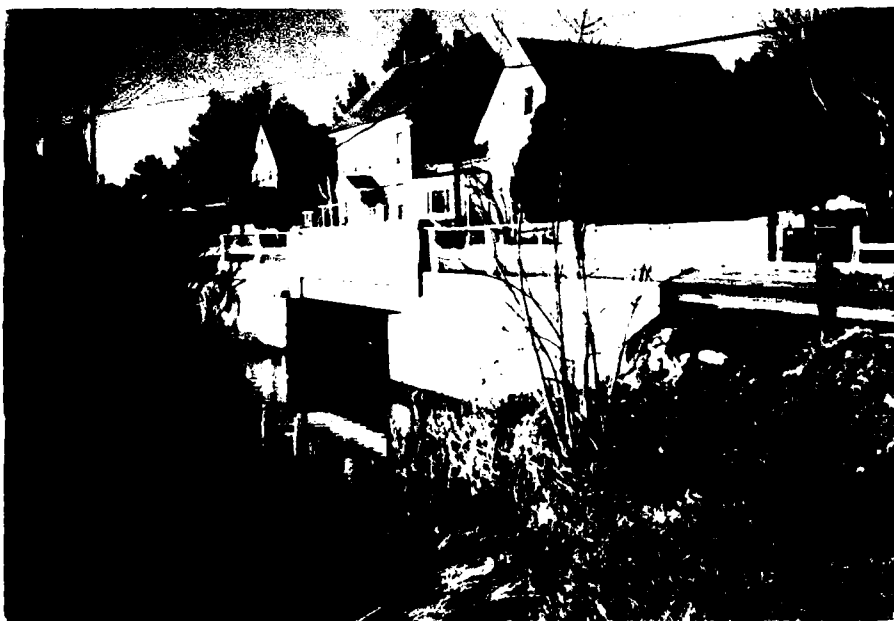
12

DOWNSTREAM VIEW OF BRIDGE 0.7 MILES DOWNSTREAM
FROM NEW DURHAM DAM
